RESTORATION OF HISTORIC CAIRO

after the 1992 earthquake

CINTEC
REINFORCEMENT SYSTEMS

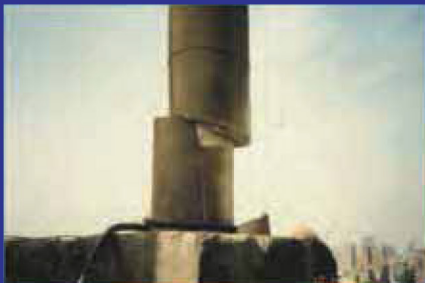
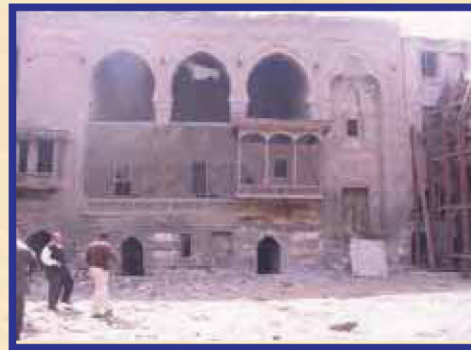
Typical damaged facade

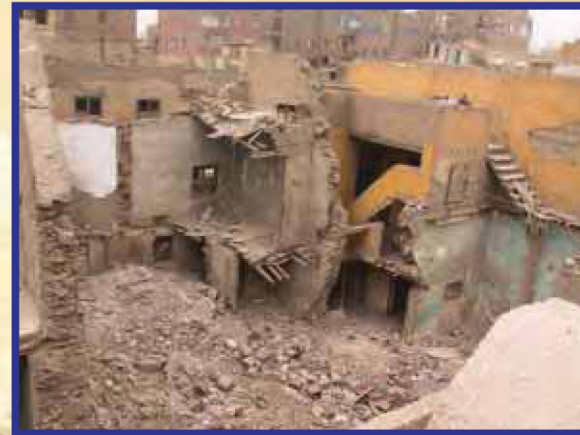
Behind the facade

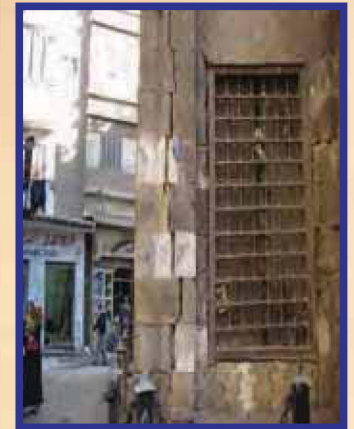
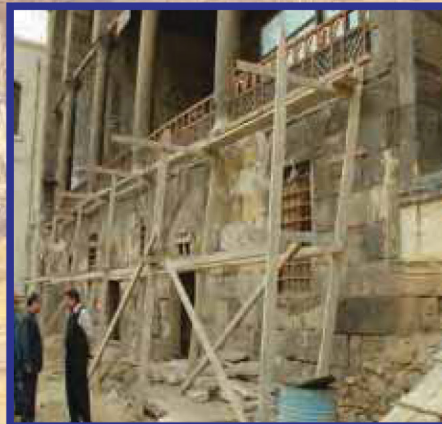
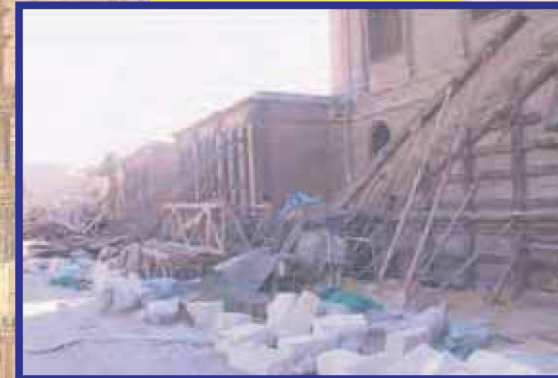
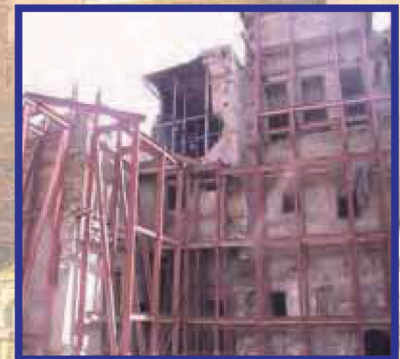
Structures with temporary supports

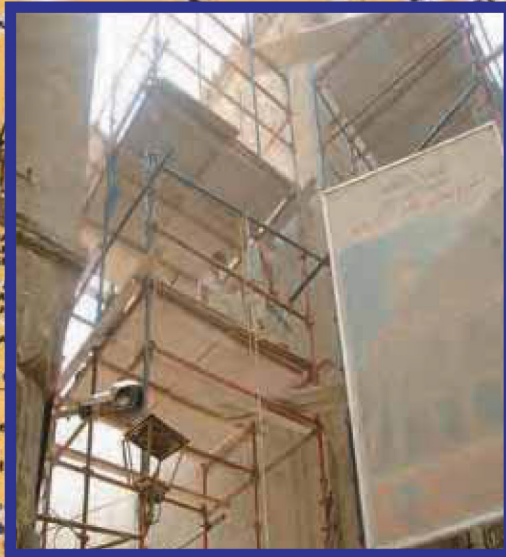
Internal cross walls stitched and secured to the external walls.

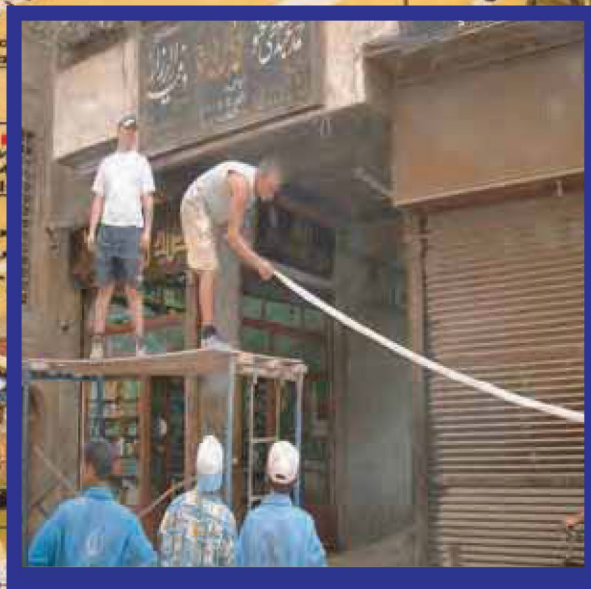
Positioning anchors in confined areas

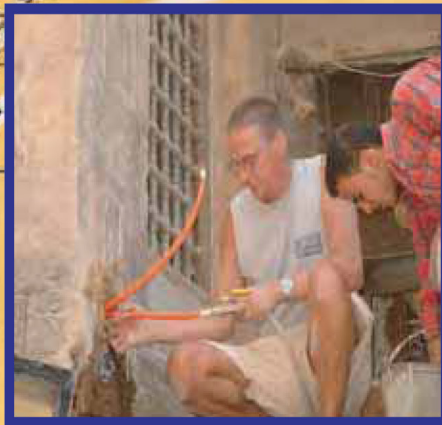
Injecting the grout from the rear to the front

Each anchor assembly is filled with grout under pressure from the rear to the front so that the entire anchor body is inflated like a balloon.

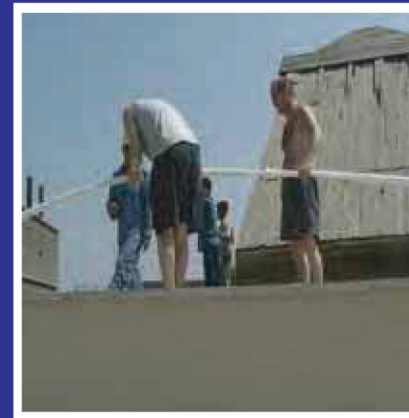
Anchor placement

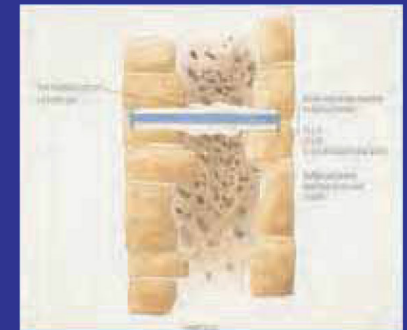
Typical consolidation tie

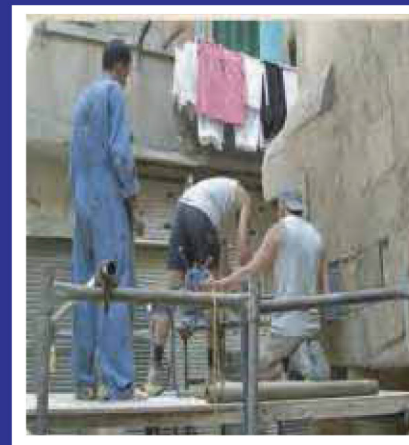
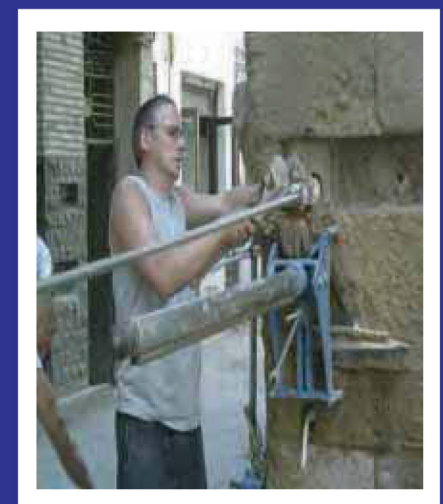
Installation of the Cintec system

Over 15,000 metres of the unique Cintec sock system was installed both to internal and external walls of the buildings. These comprised in the main of M20 stainless steel anchor bodies, M16 anchor bodies and M12 anchor bodies all in 65mm drilled holes. Smaller consolidation anchors comprising of a 10mm circular hollow section in a 32mm drilled hole. The main grout was a special Presstec White lime grout to match the existing parent material.

Internal and external walls are drilled with diamond core hollow tubes to the desired diameter.

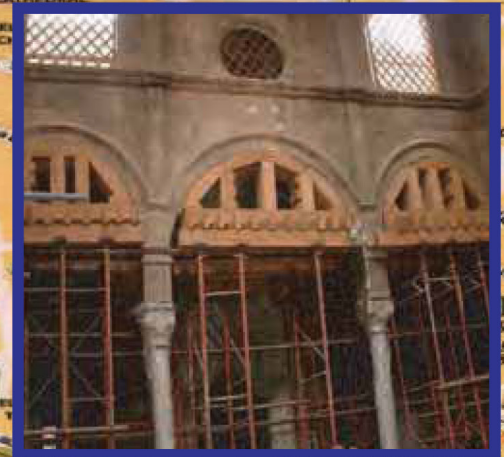
Buckling and movement of columns

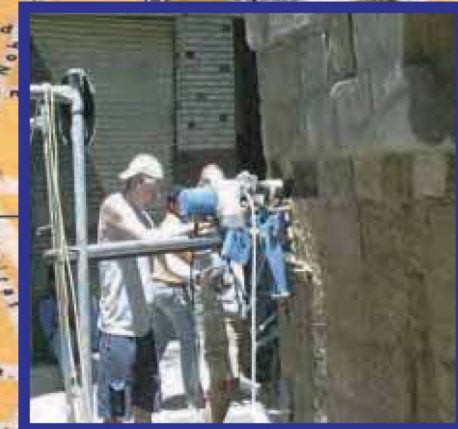
Corner stitching using diamond drilling rig

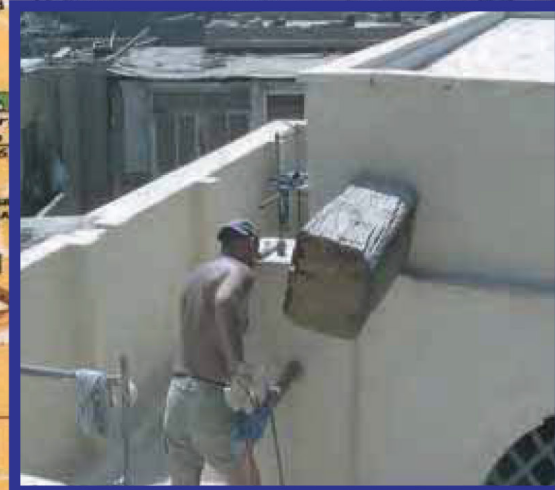
Drilling at roof level adjacent to previous timber intervention

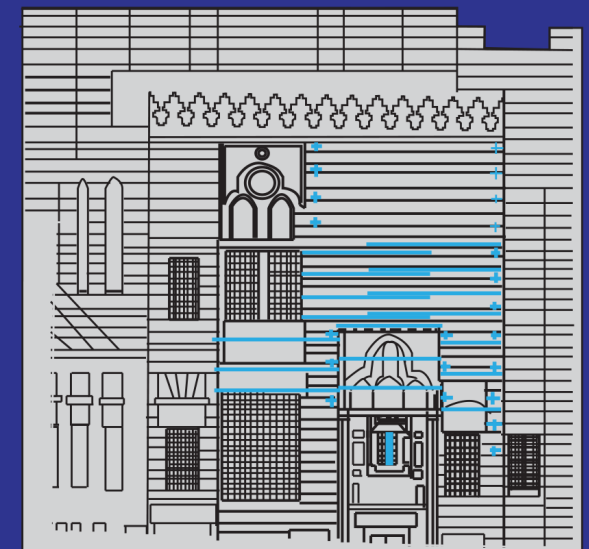
radial and consolidation anchors
