## **CINTEC ANCHORS FOR HISTORIC BODIAM BRIDGE**

**Tim Bilson**

Scoll Wilson Kirkpatrick

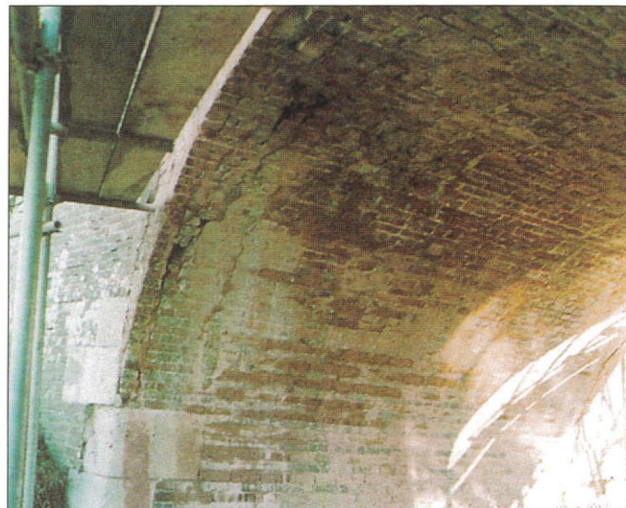
*Typical damage to the soffit of the bridge*

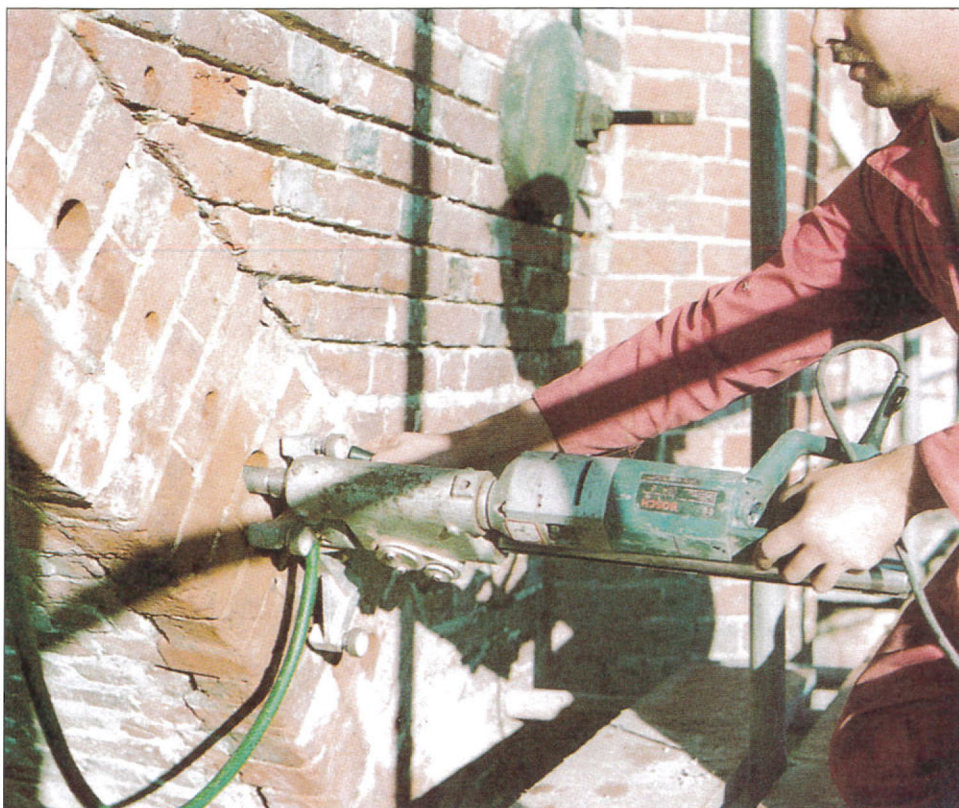
*Core drilling holes for the anchors*

nearer the centre-line of the bridge causing new cracking at this point. Strengthening of the local edge damage to the brickwork of the arches is achieved with the installation of 450mm long RAC anchors formed with 8 x 1.5mm circular hollow sections. The interspacing of the two anchors allowed the 15mm diameter holes for the small anchors to be used for the fixing of the stand used with the diamond drilling of the 52mm holes for the main anchors, this keeping the making good to a minimum. Following grouting of the anchors the holes were made good with coloured mortar to match the brickwork.

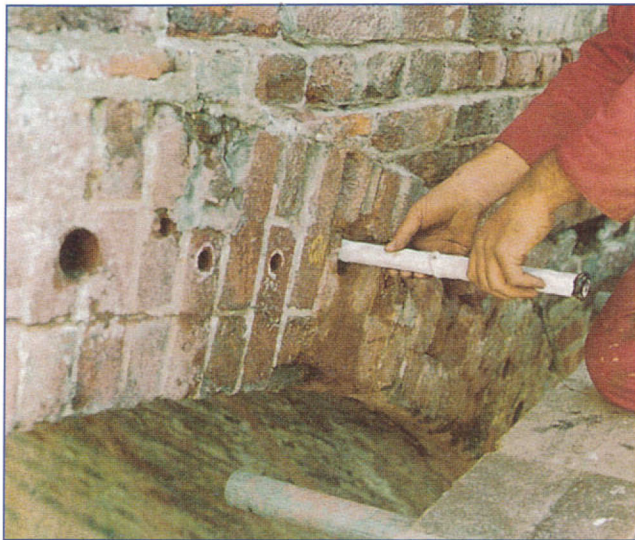
*Placing the anchor in the prepared hole*

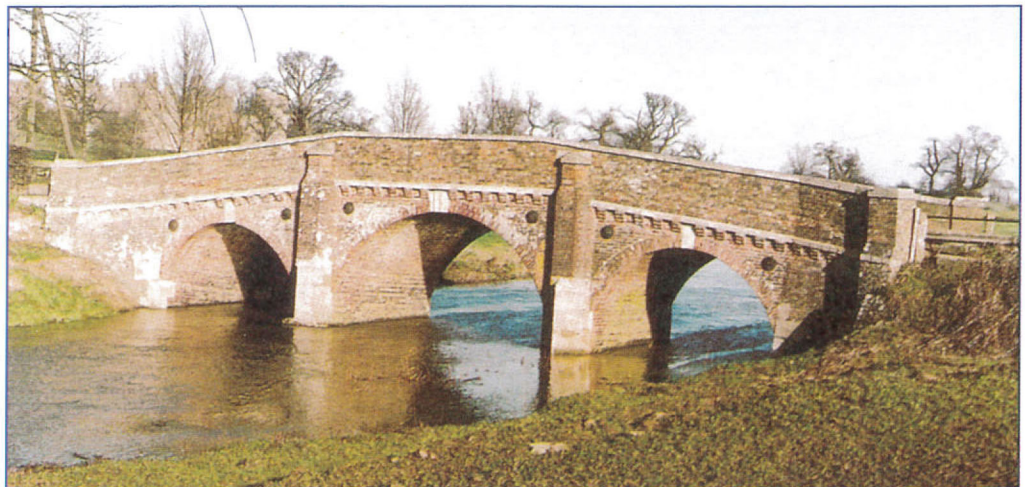
*Bodiam bridge after completion with the castle behind the trees in the background.*

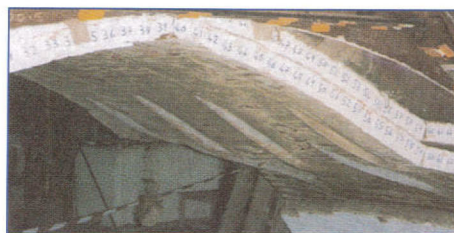
The conclusion of the TRL test, after a load failure point was raised to 41 tonnes. The picture clearly shows the exposed anchors retaining load-bearing capacity.
